THE EVALUATION OF PROTECTIVE COATINGS AND THEIR EFFECT ON SALT FORMATION ON BRICK SUBSTRATE

A THESIS

Historic Preservation

2002

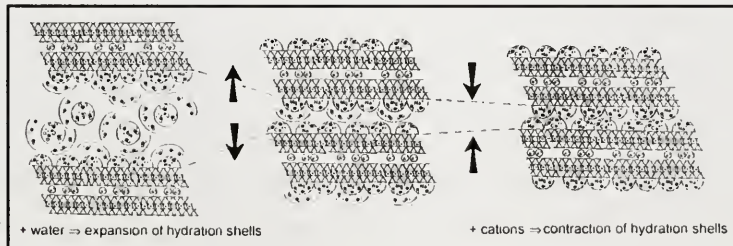
Figure 2.1 The Effect of Introducing Salts and Water to a Colloid System of Clays. From Snethlage and Wendler (1997) Figure 2.7 p. 14, after Snethlage (1990).

Snethlage and Wendler immersed blocks of Sander Schilf sandstone in NaCl solution, then dried the samples at 35% relative humidity and observed any shrinking and swelling. (See Figure 2.1) They found that contraction took place in the presence of salt solutions (instead of expansion) due to the “formation of dense hydration shells between the grains, which become denser as electrolytes become stronger.”⁶⁴ Then during drying, expansion occurred.

While the reason that expansion takes place when the samples dry is not clear, Snethlage and Wendler propose that this may be due to salt crystallization within larger

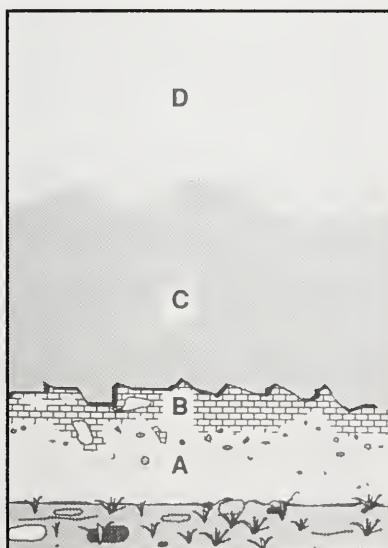
Figure 2.2 The Different Zones Observed in the Area of Rising Damp on a Wall. From Arnold and Zehnder (1990, Figure 1, p. 39.)

a wall, while the more soluble and hygroscopic chlorides and nitrates gather in the upper portions. Finally, in zone D, no damage is observed as this area is beyond the reach of capillary rise.⁷¹ In zone A, there is less deterioration than in B, where most salt efflorescences, mostly consisting of sodium carbonate, sodium sulfate, magnesium sulfate, calcium sulfate and potassium nitrate, appear and cause disintegration, crumbling and scaling. In zone C, which can be several centimeters to several meters high, is where chlorides and nitrates usually accumulate and result in “dark and humid” patches.⁷² humidity may be taken up and spread over larger areas of the walls.⁷³

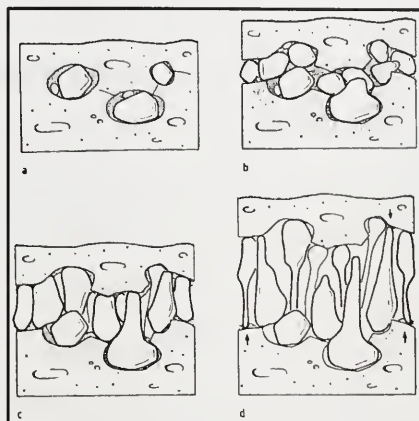
Figure 2.3 Model of Disruption Process by Crystallizing Salts (nitronatrite). From Arnold and Zehnder (1990, Figure 11 p. 42.)

it also showed that the deeper the crystallization front, the more decay is present.¹⁰² In their study, Arnold and Zehnder describe the process by which this deterioration occurs (Figure 2.3).

First (Figure 2.3 a) salts crystallize in pores of about 1 to 10 microns; smaller pores remain empty with these smaller pores and connecting channels supplying the solution for crystallization to occur. “Thus we assume that the pores in this phase and on this particular place are largely filled with a saturated or supersaturated solution.”¹⁰³ In the next phase (Figure 2.3 b) the crystals have outgrown their original pores, grow into others, and begin to coat larger voids. Since the crystals are larger than the pores, “we presume that important pressures are built up on the pore walls resulting in a [tensile] stress perpendicular to the surface. In consequence, this force will disrupt the structures preferentially by fissures parallel to the surface along a zone where the pores being filled

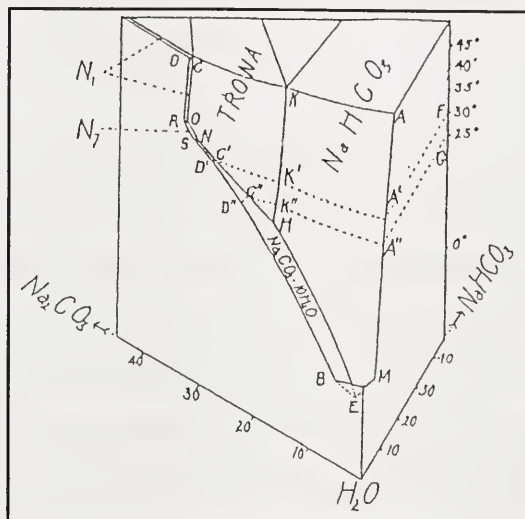
Figure 3.1 Space Model of the NaHCO_3 - Na_2CO_3 - H_2O System. From Hill and Bacon (1927, 2494.)

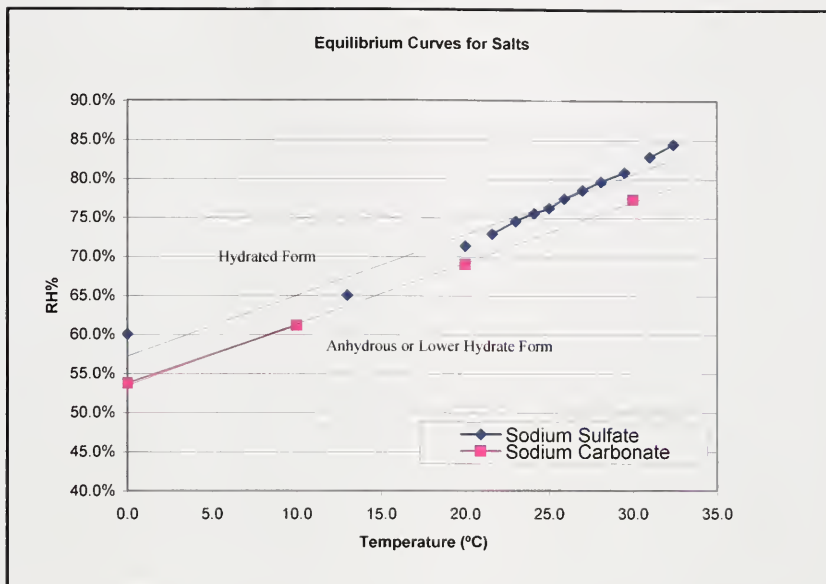
Figure 3.3 Equilibrium Curves for Sodium Sulfate and Sodium Carbonate.

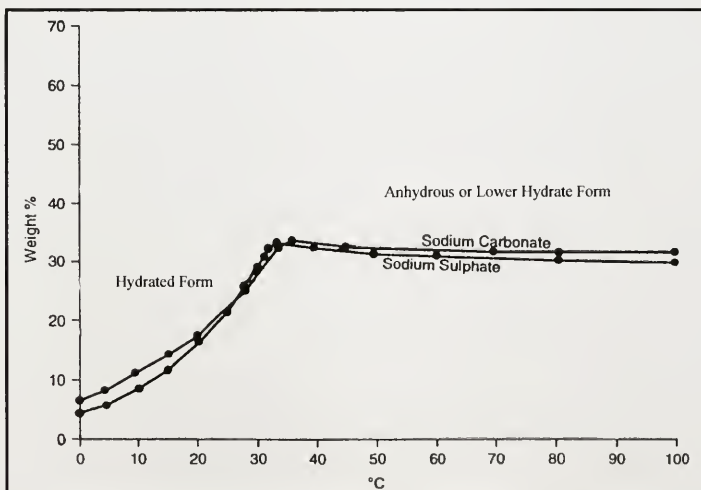
Figure 3.4 Solubility of Different Salts in Relation to Solution Temperature. From Goudie (1977: figure 6). Adapted from Goudie and Viles (1997, 109.)

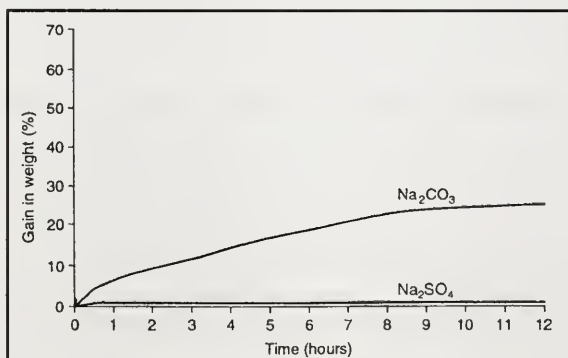
Figure 3.5 Hydration rate of Na_2SO_4 and Na_2CO_3 at 20°C and at a Relative Humidity of 90%. From Kwaad (1970: figure 3). Adapted from Goudie and Viles (1997, 137.)

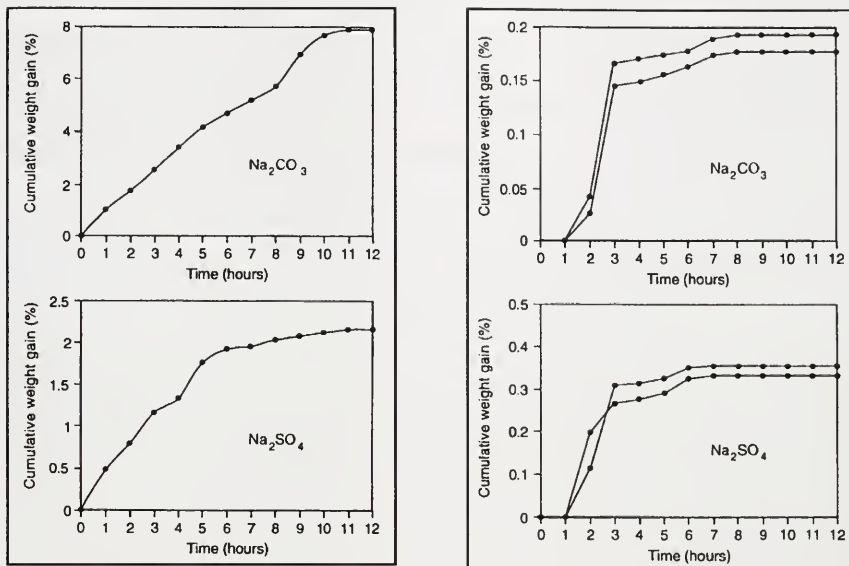
Figure 3.6 Left: Hydration rates of Na₂SO₄ and Na₂CO₃ pre-dried for 24 hours at 105°C and set into 90% at 25°C. Right: Hydration rates for blocks of York stone immersed in saturated solutions of these salts, dried and set into 90% RH at 25°C. From Goudie and Viles (1997, 138-9.)

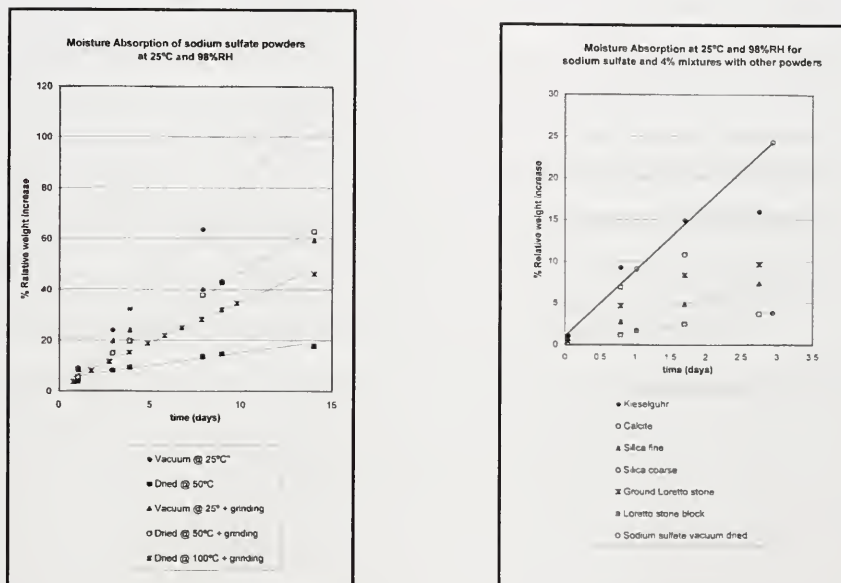
Figure 3.7 Moisture Absorption Rates for Sodium Sulfate Powders and Sodium Sulfate/Stone Powders. Based on data from Charola and Weber (1992).

hydration rates they observed for sodium carbonate. The complex interaction of the support in the hydration rate of sodium sulfate is shown in Figure 3.7. It has been shown that both the substrate and the previous history of the salt plays an important role in the moisture absorbing capability of sodium sulfate.¹²³

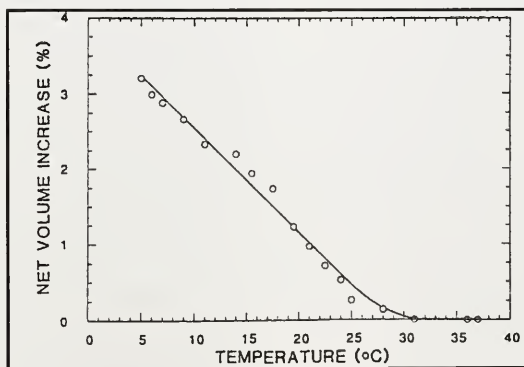
Figure 3.8 Volume Increases During the Precipitation of Mirabilite from a Supersaturated Solution. From McMahon et al. (1992) Figure 4, 711.

McMahon et al. found that simple calculations did not adequately explain any difference between deterioration mechanisms and sought to elucidate the deterioration by sodium sulfate by isolating the possible mechanisms, such as volume increase as a result of hydration or crystallization from a supersaturated solution, comparing the deterioration caused by each. The different conditions produced: rapid crystallization of mirabilite by immersion in sodium sulfate solution then rapid cooling; crystallization of mirabilite through evaporation; crystallization of mirabilite through evaporation and low temperature fluctuations; crystallization of thenardite through evaporation and hydration cycles; and crystallization of thenardite through evaporation.¹²⁴

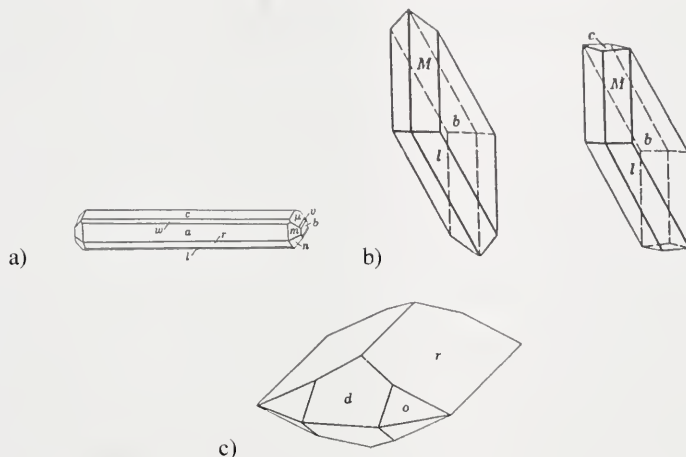
Figure 3.9 a) Mirabilite Crystal Structure, from Dana and Dana, 1966, p. 440; b) Natron Crystal Structure, from Dana and Dana, 1966, p. 483; c) Thenardite and Thermonatrite Crystal Structure, from Dana and Dana (1966), 405.

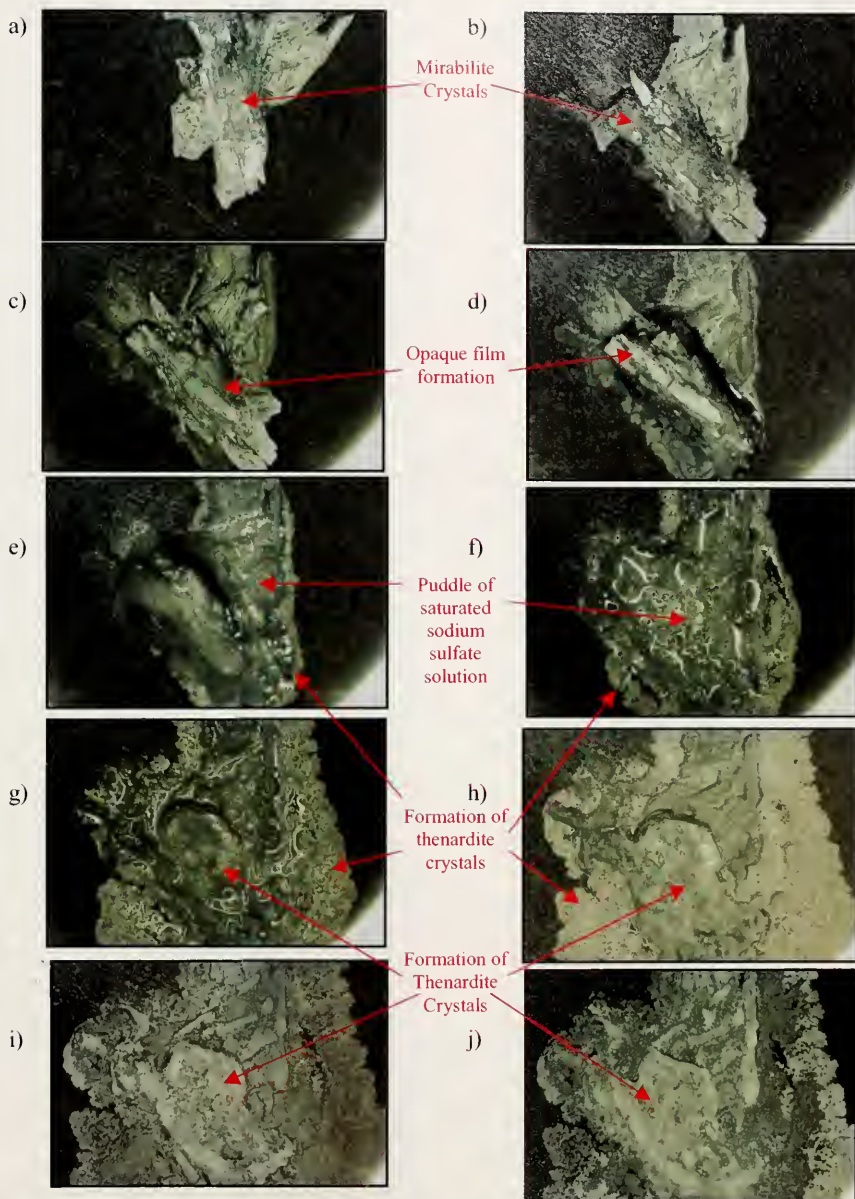
Figure 3.10 Dehydration of Mirabilite Crystals to Thenardite Under Gentle Heat; Nikon SMZ-U Zoom 1-10 Stereoscope with Quartz Halogen Lamp. Magnification 1.25 x.

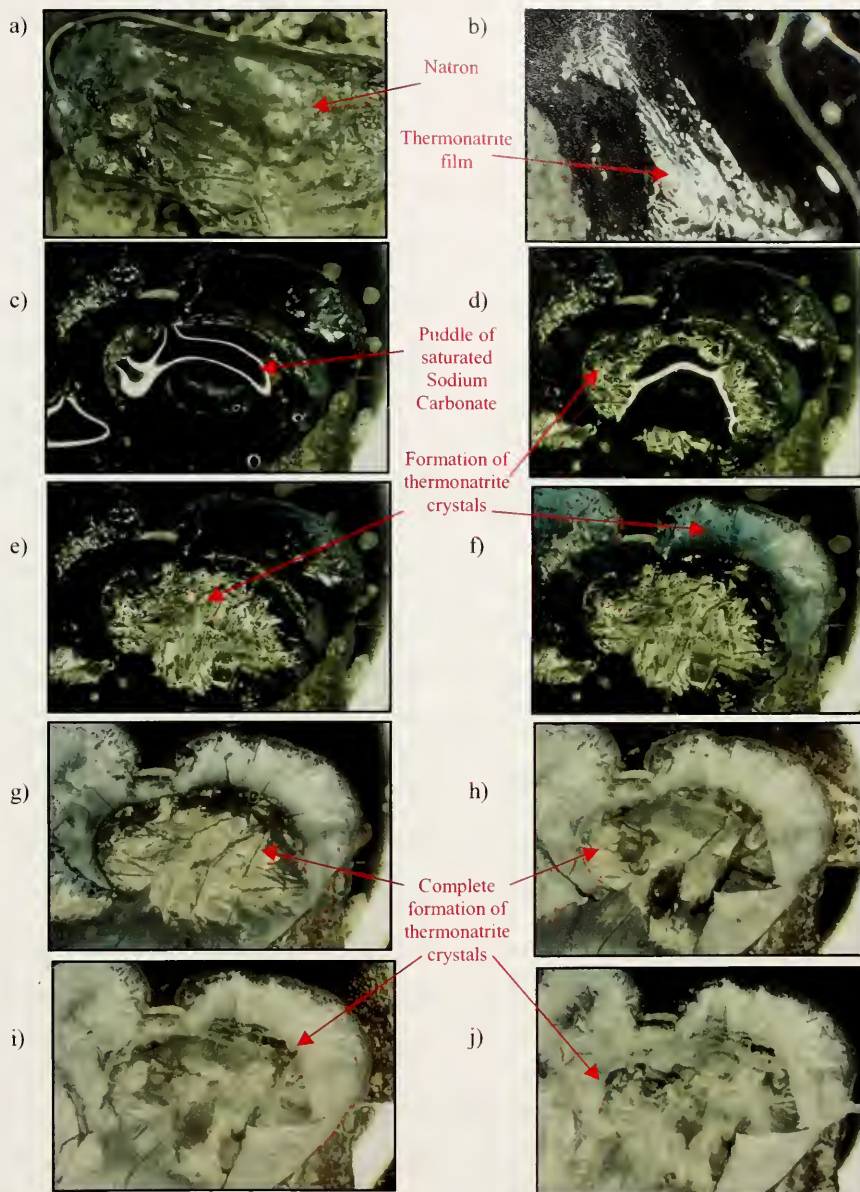
Figure 3.11 Dehydration of Natron to Thermonatrite Under Gentle Heat; Nikon SMZ-U Zoom 1-10 Stereoscope with Quartz Halogen Lamp. Magnification 1.25 x.

The dehydration of natron was also observed. The behavior of one large transparent crystal was followed (Figure 3.11 a). Upon exposure to heat, the crystal formed an opaque film of thermonatrite on the surface (Figure 3.11 b). It quickly dissolved, however and became a puddle of saturated solution (Figure 3.11 c). During this phase, smaller opaque crystals began forming at the edges of this solution and the puddle appeared to cave in on itself (Figure 3.11 d). From the outer edges of the central portion of the puddle more transparent crystals of thermonatrite began to form working their way inward toward the center (Figure 3.11 d-e). The smaller crystals on the outer ring of the puddle continued to grow in opacity, as did the central core as it dehydrated (Figure 3.11 f-g). At this point small crystals dehydrate until the entire formation was opaque (Figure 3.11 h-j). The thermonatrite crystals in the center grew larger, as did those at the edge. The main difference between the dehydration of these salts is that while sodium sulfate produces many extremely small crystals of thenardite, sodium carbonate forms lesser and bigger crystals of thermonatrite.

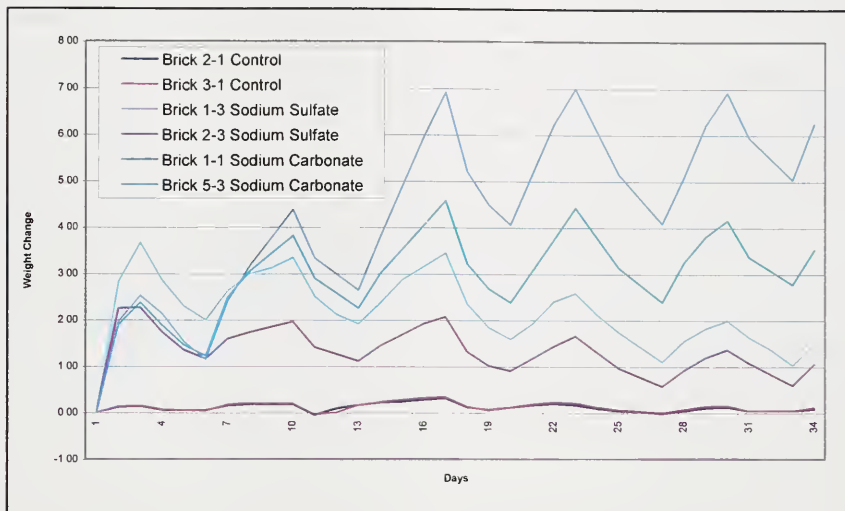
Figure 3.12 Results of Cycling Sodium Carbonate and Sodium Sulfate Impregnated Bricks Between 20% RH and 100% RH; Cycling period: 3 days each condition, repeated for 12 cycles.

weight gain and a greater difference in weights between low RH and high RH as compared to sodium sulfate decahydrate treated samples.

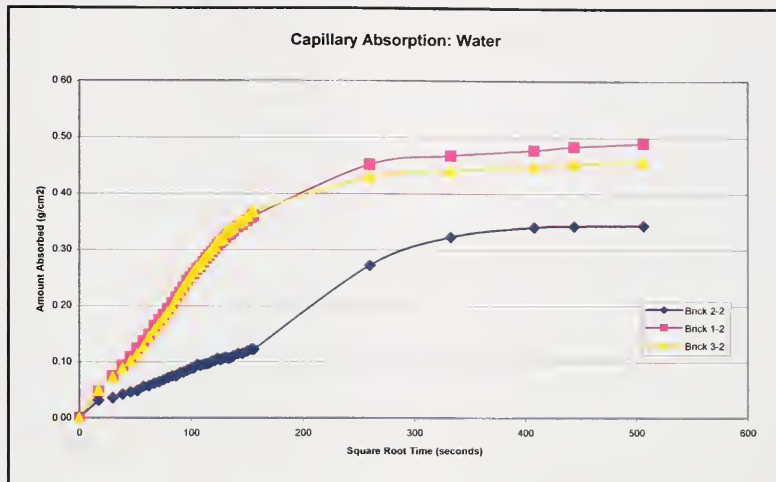
Figure 5.1 Capillary Water Absorption Rates of Sample Bricks

Capillary absorption rates were obtained for the sample brick following the NORMAL 11/85 procedure. Samples were cut into 5 x 5 x 5.5 centimeter cubes from the center of the brick units for these tests. At least one side consisted of the “fireskin”, through which absorption took place; the rest of the sides were cut using an electric wet masonry saw with a diamond blade. The capillary absorption curve obtained is presented below. (Figure 5.1)

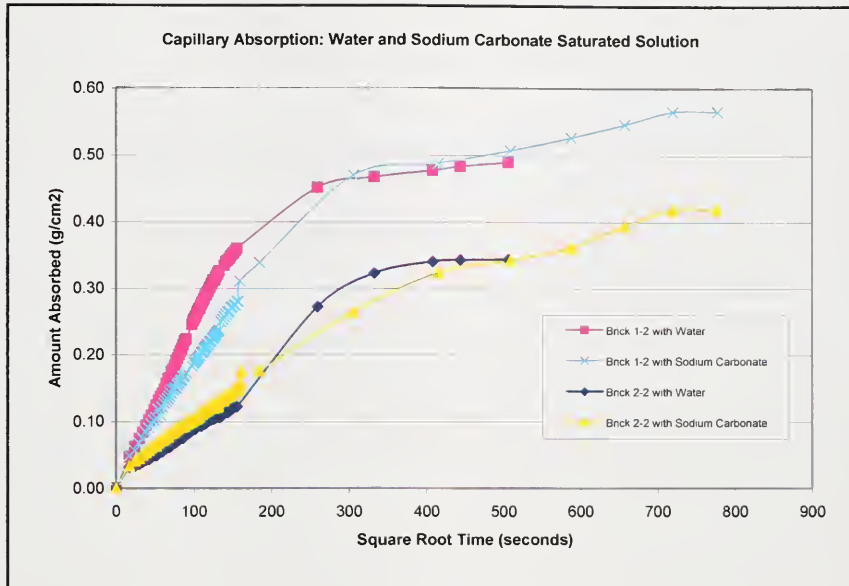
Figure 5.2 Capillary Absorption Curves of Brick Samples: Comparison of Water and Sodium Carbonate Saturated Solution Absorption Rates

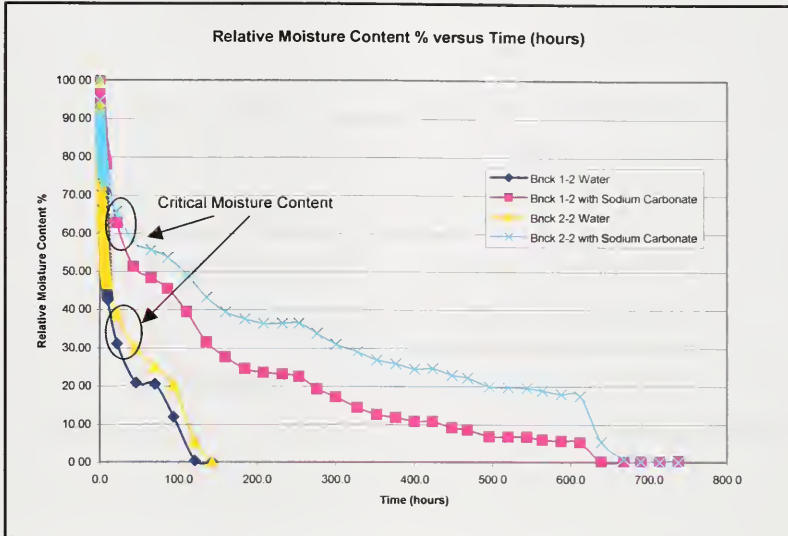
Figure 5.3 Drying Curves of Brick Samples with Water and Sodium Carbonate

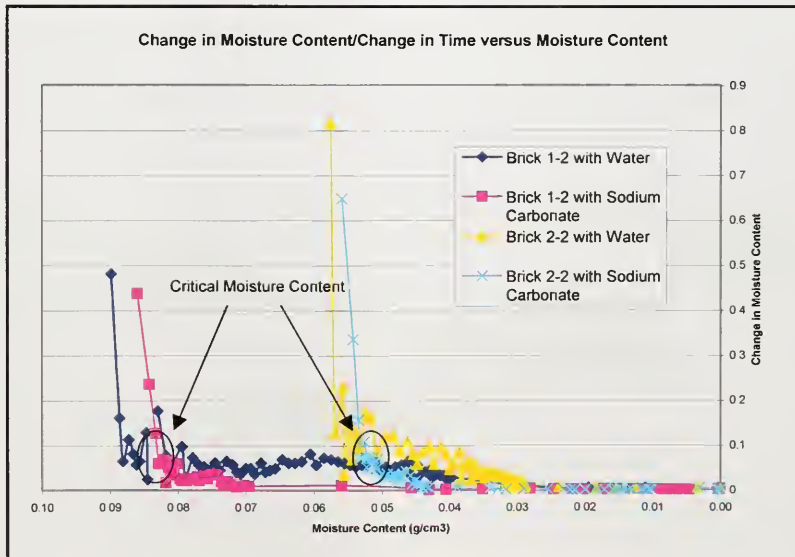
Figure 5.4 Drying Rate Curves of Brick Samples with Water and Sodium Carbonate

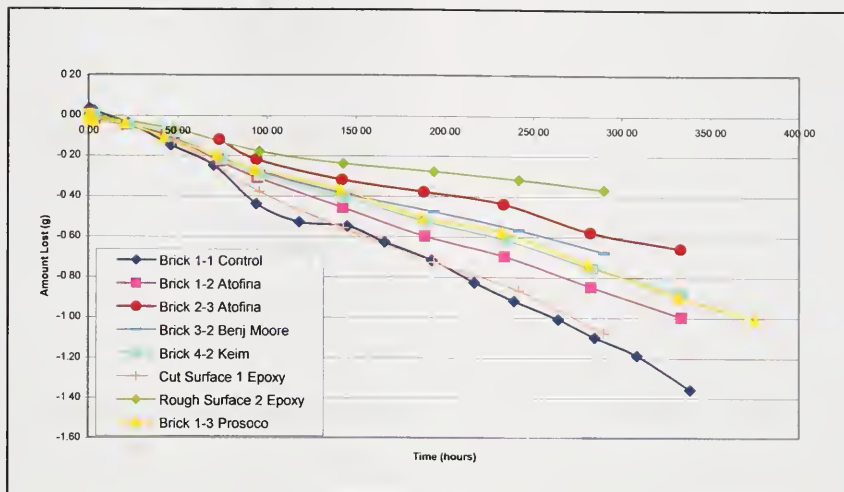
Figure 5.5 Sampling of Water Vapor Transmission Rates

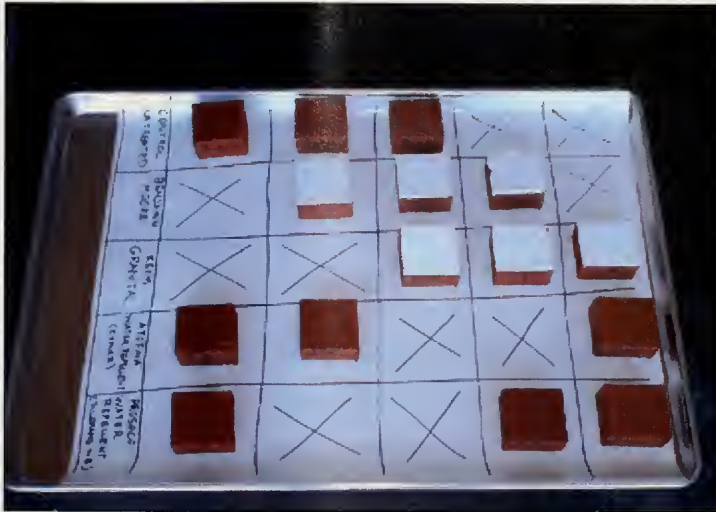
Coated Samples for Water Vapor Permeability Test

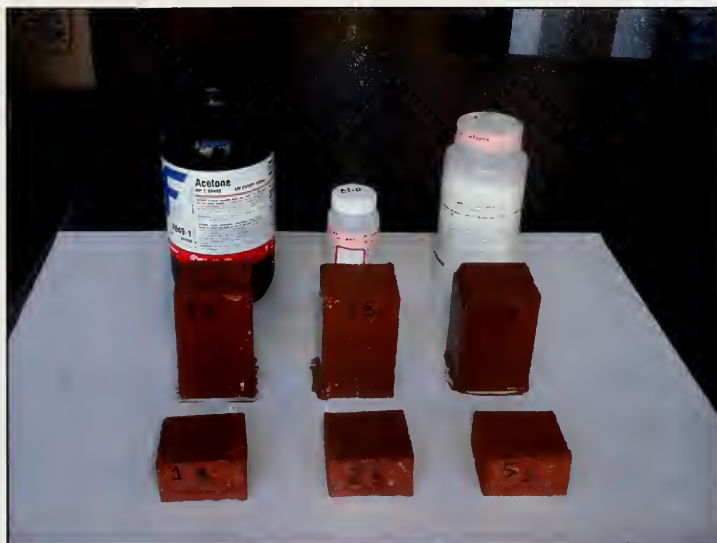
Sample Preparation Using Kynar RC-10,052 PWD PVDF and Acetone

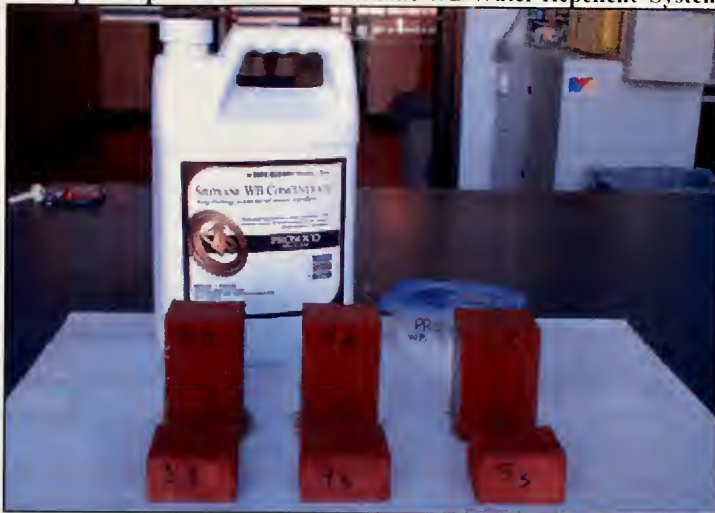
Sample Preparation Using Prosoco Siloxane WB Water Repellent

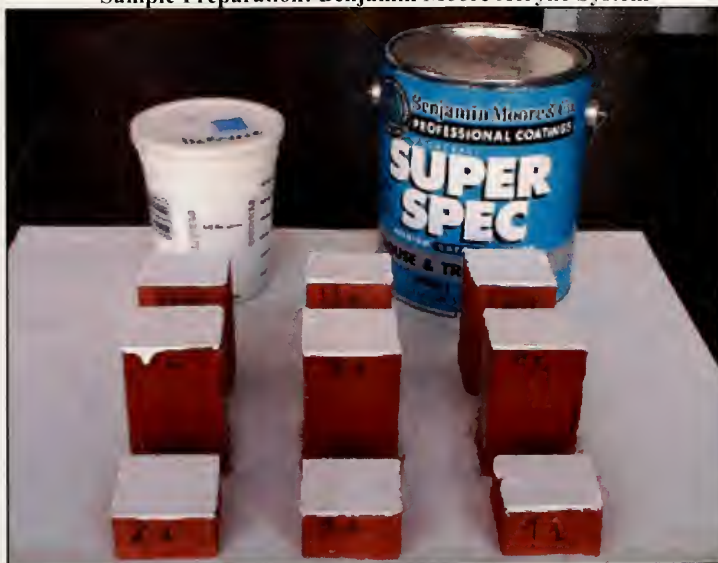
Sample Preparation Using High-Build Acrylic Masonry Primer and Superspec 100% Acrylic Exterior Masonry Coating

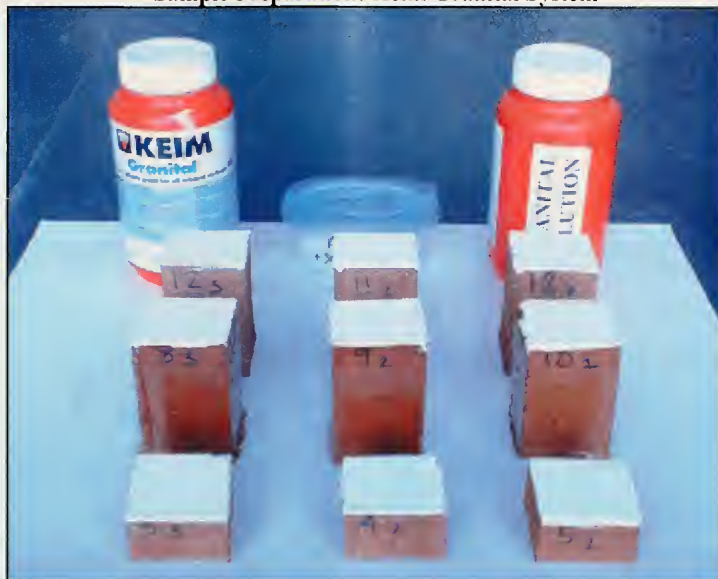
Sample Preparation Using Kiemfarben GmbH Granital with Keim Dilution Potassium Silicate System

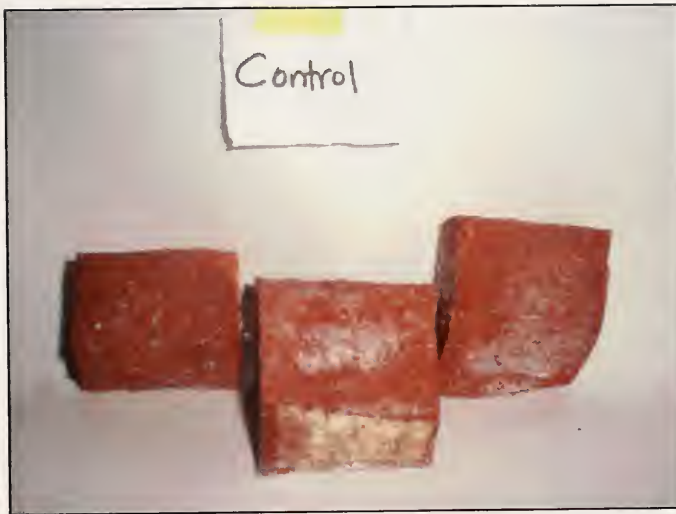
Salt Front of Control Samples

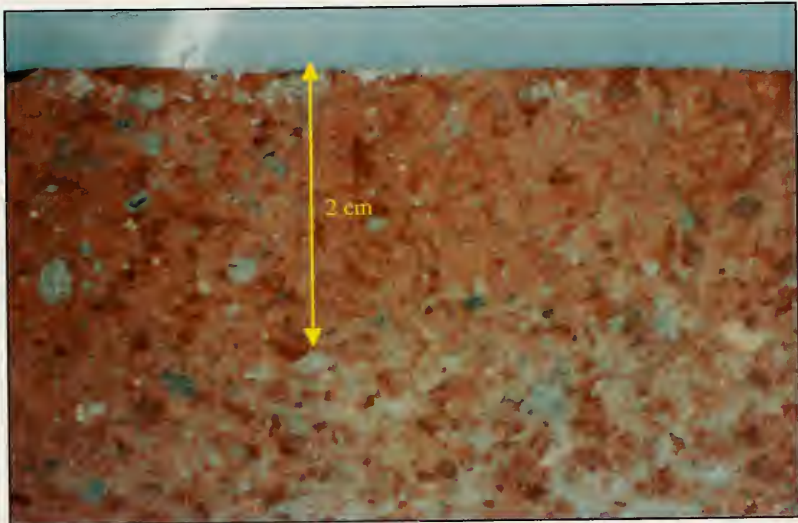
Salt Front of Control Samples: Nikon SMZ-U Zoom 1:10
0.5x Magnification; 200 ASA

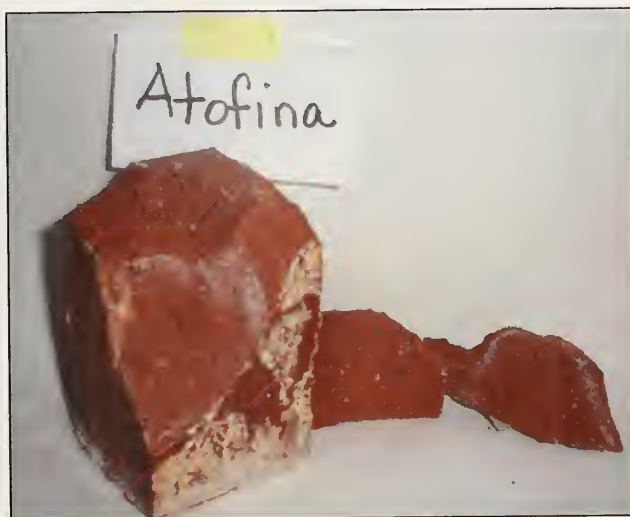
Salt Front of Atofina Kynar Treated Samples

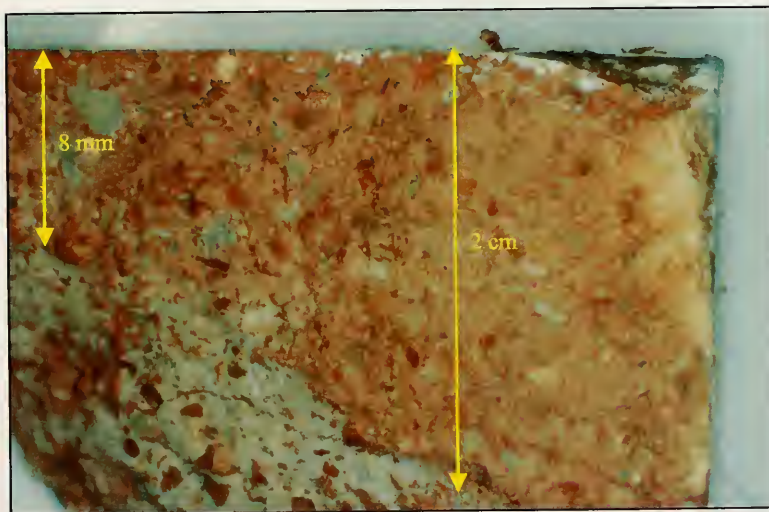
Salt Front of Atofina Kynar Treated Samples: Nikon SMZ-U Zoom 1:10
0.5x Magnification; 200 ASA

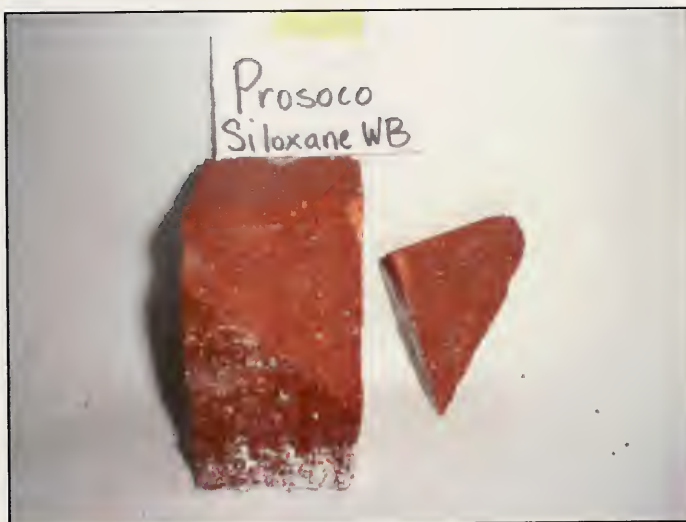
Salt Front of Prosoco Siloxane Treated Samples

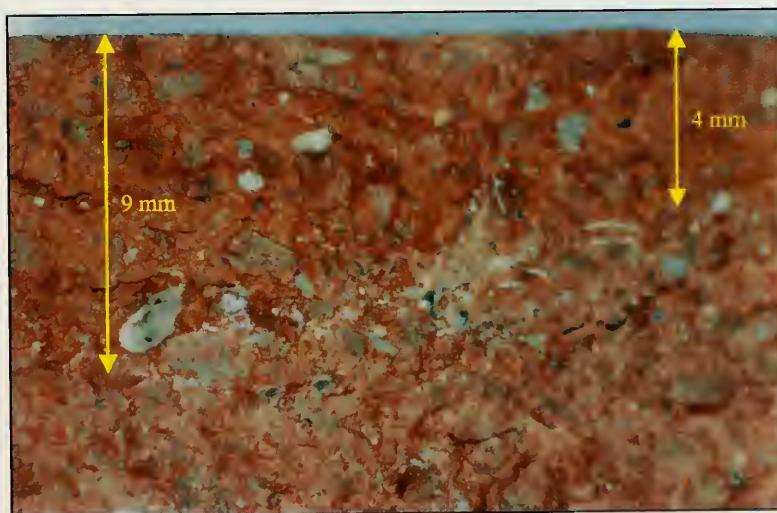
Salt Front of Prosoco Siloxane Treated Samples: Nikon SMZ-U Zoom 1:10
0.94x Magnification; 200 ASA

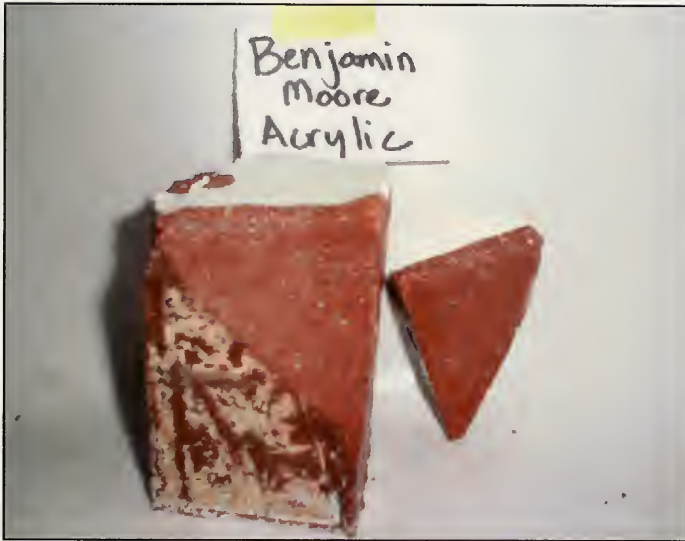
Salt Front of Benjamin Moore Treated Samples

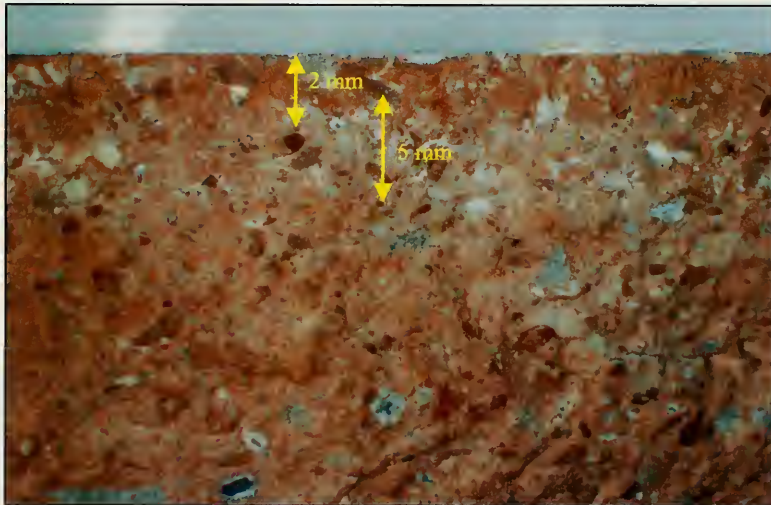
Salt Front of Benjamin Moore Treated Samples: Nikon SMZ-U Zoom 1:10
0.5x Magnification; 200 ASA

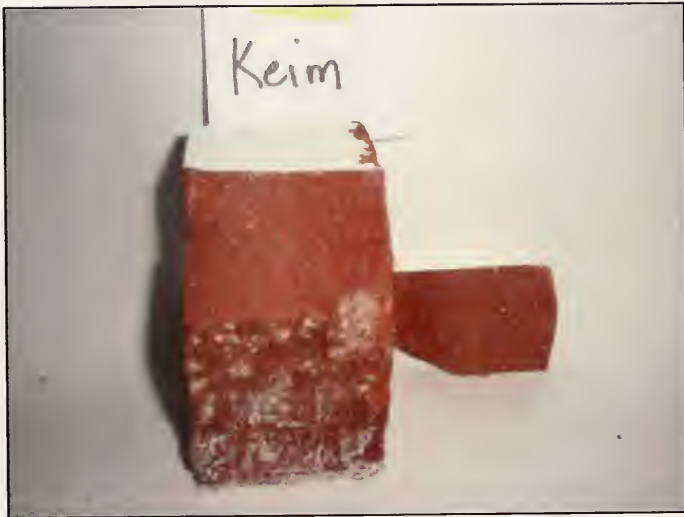
Salt Crystallization in Keim Granital Treated Samples

Keim Granital System	no obvious salt front	crystals are distributed evenly throughout sample, with no visible salt front and no area where crystals do not form

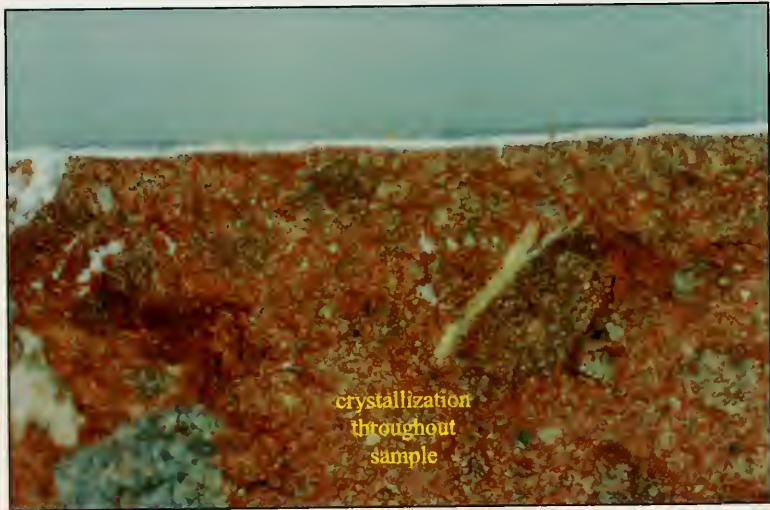
Salt Crystallization in Keim Granital Treated Samples: Nikon SMZ-U Zoom 1:10
2.5x Magnification; 200 ASA
